Mandatory Service Bulletin
No. MSB-E4-014/2

MANDATORY SERVICE BULLETIN

No. MSB-E4-014/2
SUPERSEDES MSB No. MSB-E4-014/1

Replacement of the Fuel Return Line and Banjo Fitting

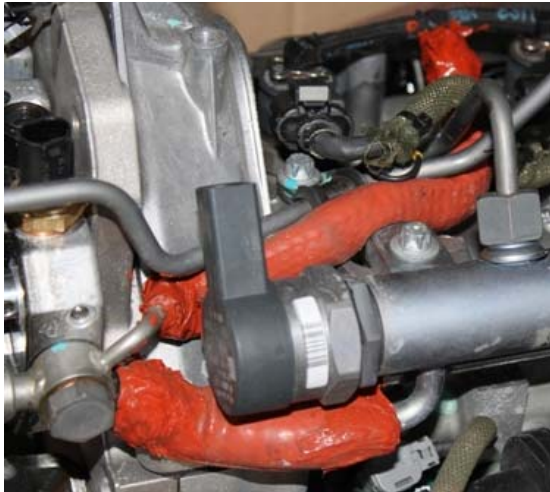
Step 1

Initial situation.

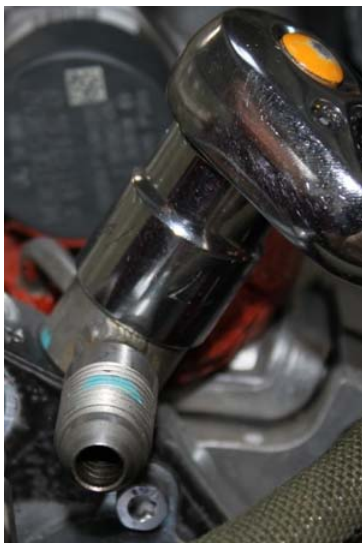
Step 3

Disconnect the Banjo Fitting [1].

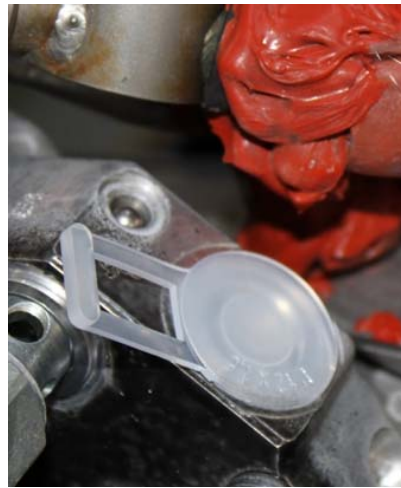
Step 4

Plug the High Pressure Pump outlet to avoid contamination of the fuel system.

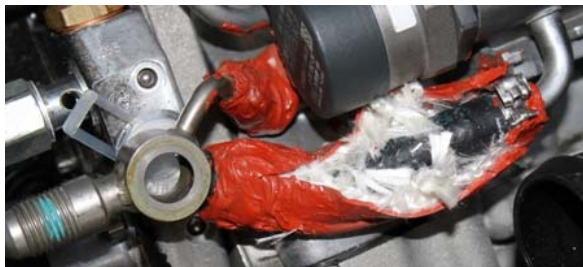
Step 5

Disconnect the Rail Return Line [3].

Take care not damaging the Rail Return Line while demounting the fire sleeve. The Rail Return Line including Clamps need to be reinstalled.

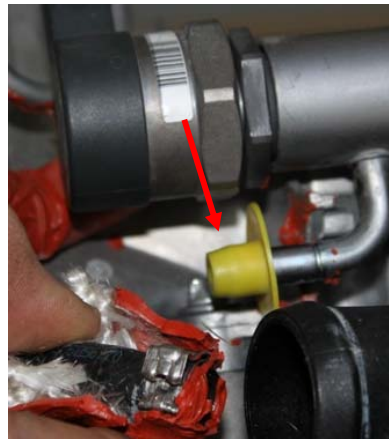
Step 6

Plug the Rail outlet to avoid contamination of the fuel system.

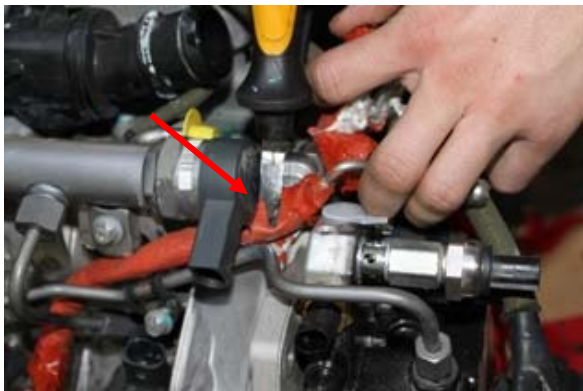
Step 7

It is possible to cut the Injector Return Line [2] for an easier disassembly.

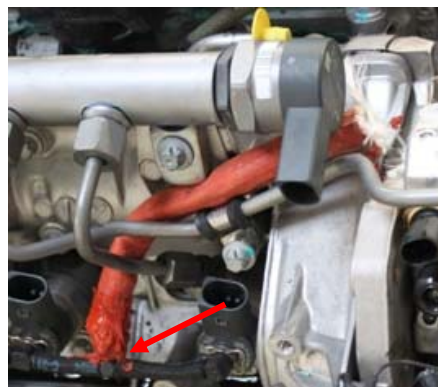
Step 8

Leave the rest of the Injector Return Line [2] connected till the final assembly to avoid contamination of the fuel system.

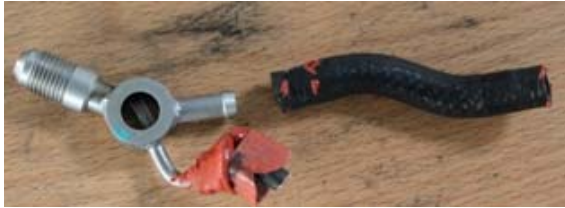
Step 9

Disassemble the Rail Return Line [3] from the old Banjo Fitting [1] and clean them from remaining sealant and fire sleeve.

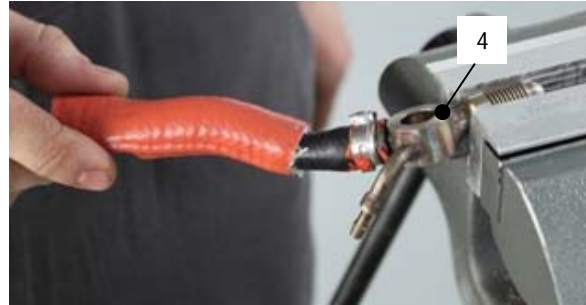
Step 10

Take the new Banjo Fitting [4] and assemble them with the Rail Return Line [3], clamp and new fire sleeve.

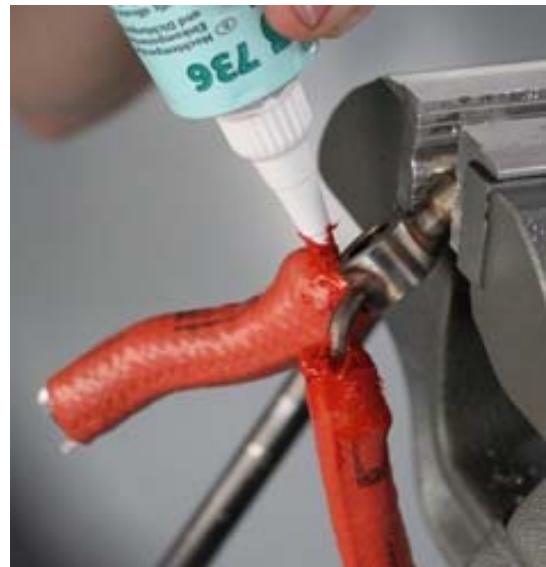
Step 12

Use sealant (for material specification see chapter 3.1) to insulate the fire sleeve ends.

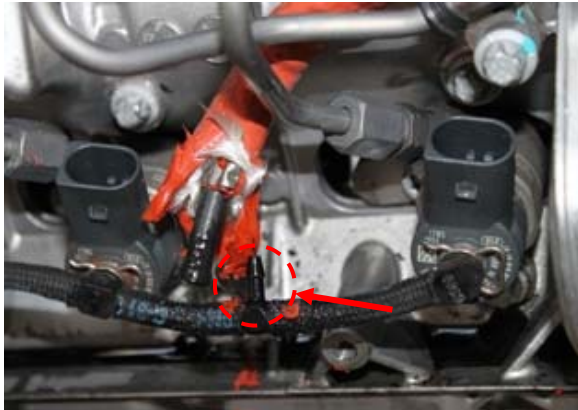
Step 13

Disassemble the Injector Return Line [2].

Take care **not** damaging the connector.

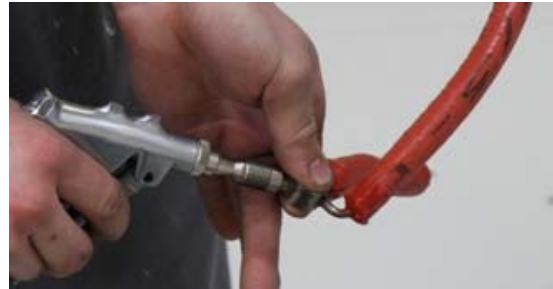
Step 14

Before assembly blast the preassembly to avoid contamination of the fuel system.

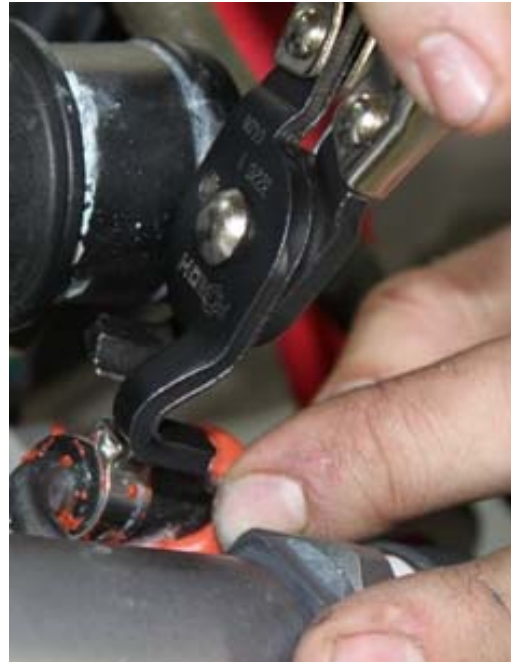
Step 16

Connect the Rail Return Line [3] to the Rail outlet using clamp tool.

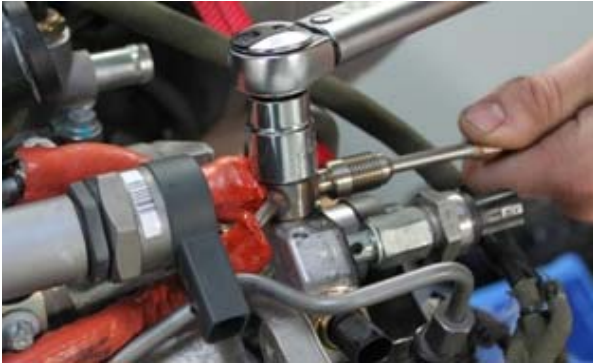
Step 17

Torque the Banjo Fitting [4] with the Banjo Bolt with 25Nm.

Do not forget to use two new washers.

4. For final installation refer to Maintenance Manual E4.08.04 chapter 85-00-12 – *“Installation of Injector Cover”*.
5. After engine ground run (which is part of scheduled maintenance procedure) torque the Banjo Bolt again with 25Nm.

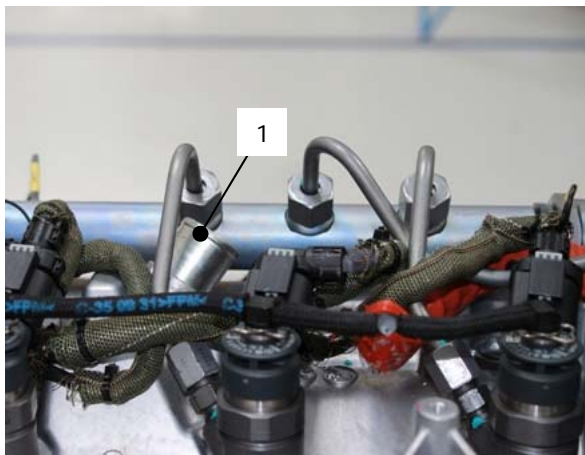
Step 20

Clean hose connection [1] on the cylinder head cover by using a dry and clean rag only.

Do not use any detergent to avoid engine oil contamination.

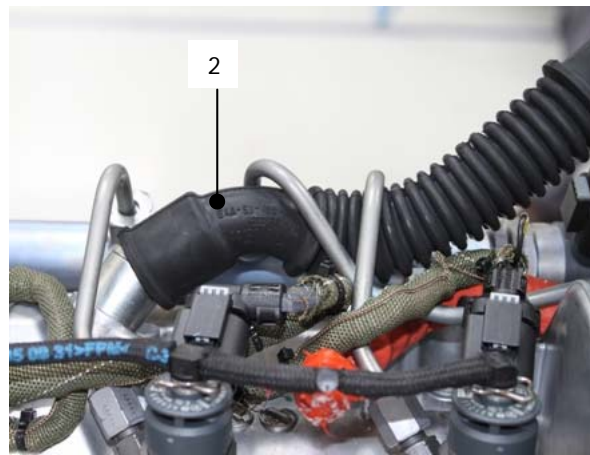
Step 21

Guide the oil separator hose [2] beneath the high pressure fuel lines as shown.

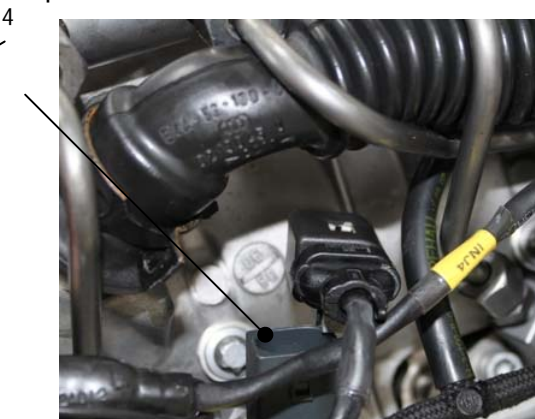
Step 23

Disconnect the injector plug [4] for an easier mounting of the oil separator hose, if required.

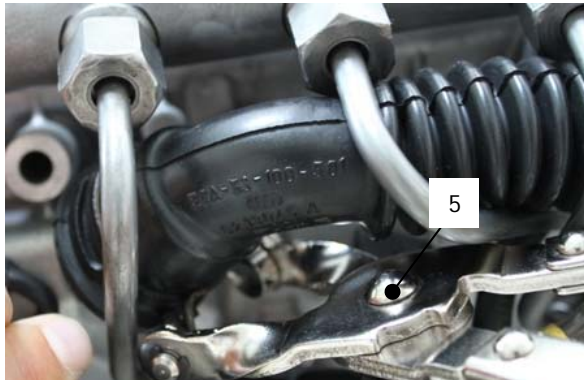
Step 24

Push the oil separator hose [2] over the hose connection [1] and fix it with the hose clamps [3].

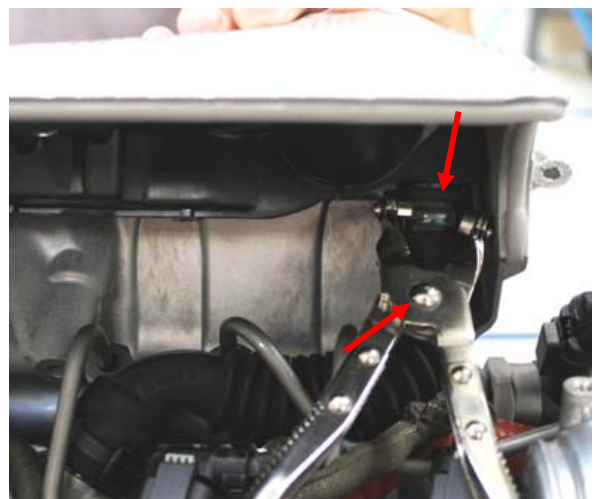
Step 27: In case the oil separator hose has been disassembled from the oil separator assembly:

Push the oil separator hose [2] on to the oil separator assembly [6] and fix them with the hose clamps [3].

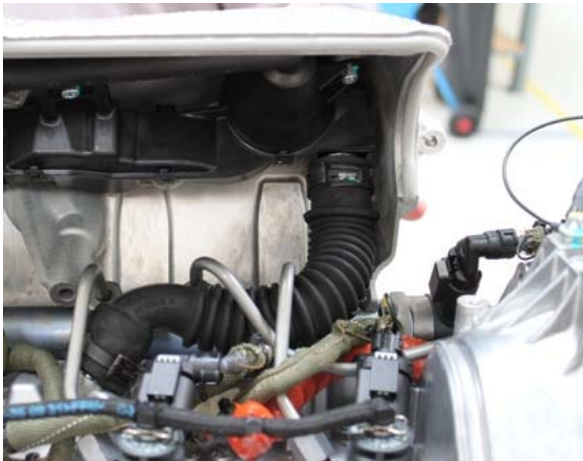
Step 28

Please take care during the oil separator hose installation that the hose is not stressed by torsion.

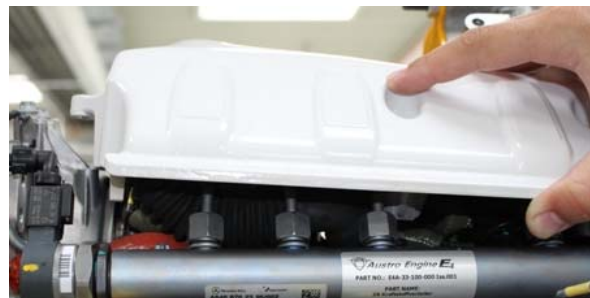
Step 29

Close the injector cover carefully to avoid stress to or jamming of the oil separator hose.

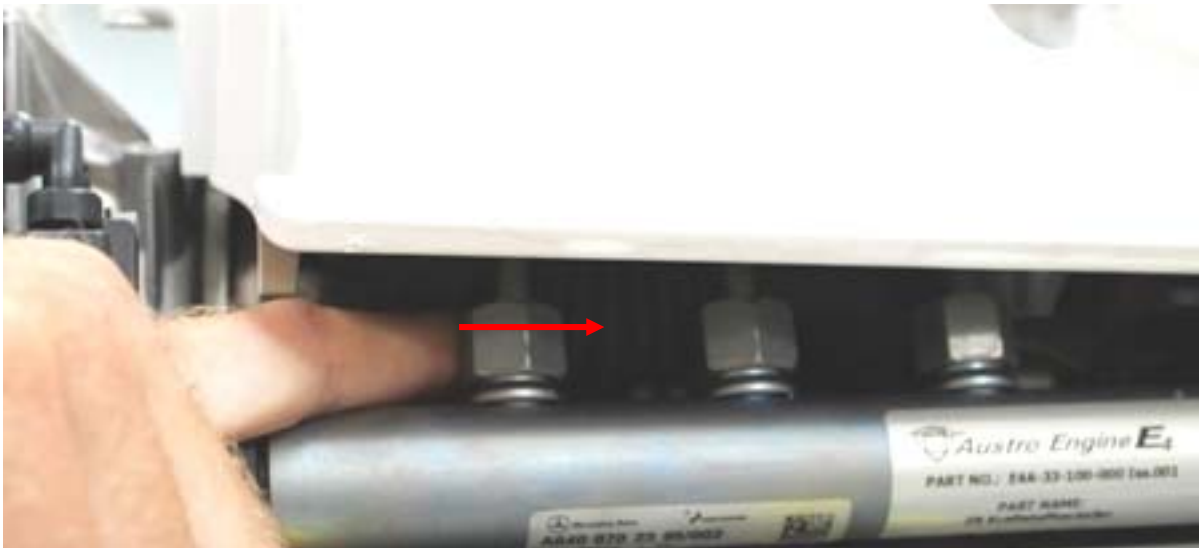
Step 30

Before mounting of the injector cover slightly push the hose towards the direction shown. This helps to avoid jamming of the oil separator hose.
